Kahnawà:ke Shoreline Vulnerability Assessment

Kahnawà:ke Environment Protection Office

**Shoreplan
Engineering Limited**

July 2018

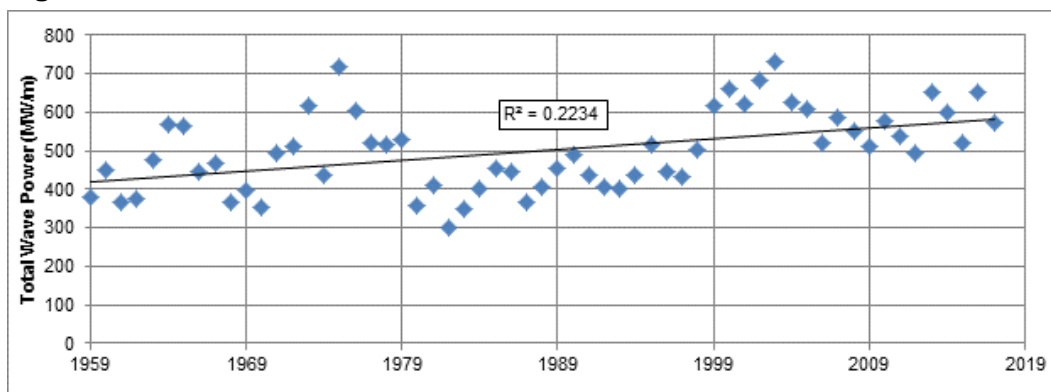
Figure 2.10 Annual Distribution of Total Wind Wave Power

Figure 2.10 shows the total annual offshore wave power for each year of the 65-year hindcast. A linear regression analysis of the data in Figure 2.10 shows an increasing wave power trend over the hindcast period. The trend line and the R^2 value from that analysis are also shown on Figure 2.10. The R^2 value is the coefficient of determination, which can be viewed as the percentage of the variation in the dependant variable (wave power) that is predictable from the independent variable (year). It provides a means of evaluating the goodness of fit of the data to the linear trend. In this instance a value of 22% is not considered to be a good fit and shows a weak correlation between the dependent and independent variables.

An increase in total wave power over time is the type of result that can be expected from climate change. While it is possible that climate change is the cause of the variability in the total annual wave power, the low correlation does not support a firm conclusion that there in fact is a rise in total wave power over time. A more thorough review of the variation in the wind conditions that generated the waves is required before any firm conclusions can be drawn about the reasons for the variation in the total wave power.

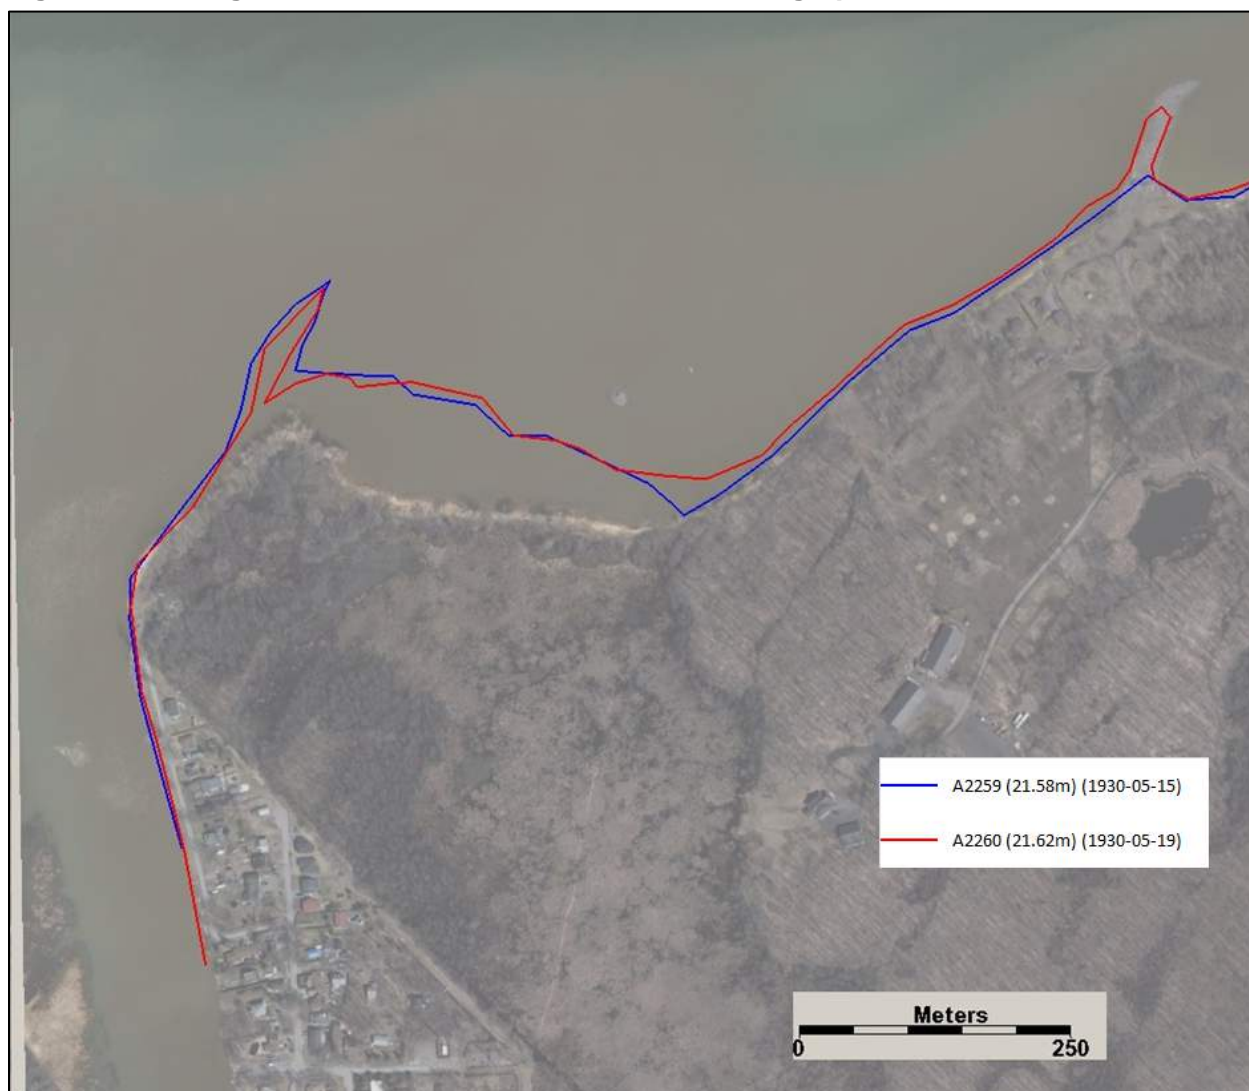
Figure 5.2 Digitized Shoreline from 1930 Aerial Photographs

An example of the accuracy difficulties is demonstrated in Figure 5.2, which shows the digitized shoreline from the two 1930s aerial photographs (A2259 and A2260) for the western end of the study area.

As shown in Table 5.1, these two photographs were taken four days apart, when there was only a 0.04m difference in the daily water levels. It would be expected that the digitized shorelines would be essentially the same throughout, yet it can be seen that there are significant differences.
