Kahnawà:ke Shoreline Vulnerability Assessment

Kahnawà:ke Environment Protection Office

**Shoreplan
Engineering Limited**

July 2018

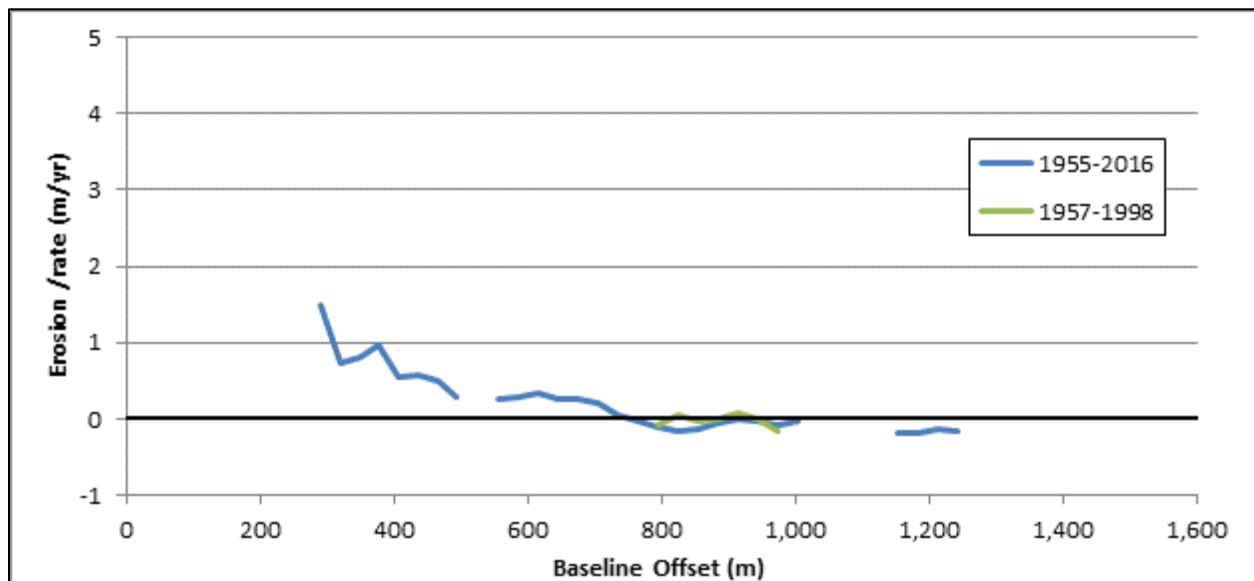
Figure 5.4 Erosion Rates - Baseline Segments 1 and 2

Figure 5.4 shows relatively high erosion rates at the western end of the study area, in front of the unprotected wetland shore of Reach 2. Lower rates are shown for the unprotected low plain of Reach 3. It is reasonable to assume similar rates will apply to the unprotected low plain shoreline of Reach 1. Reaches 1 to 3 are therefore viewed as being erosion prone if they are not protected.

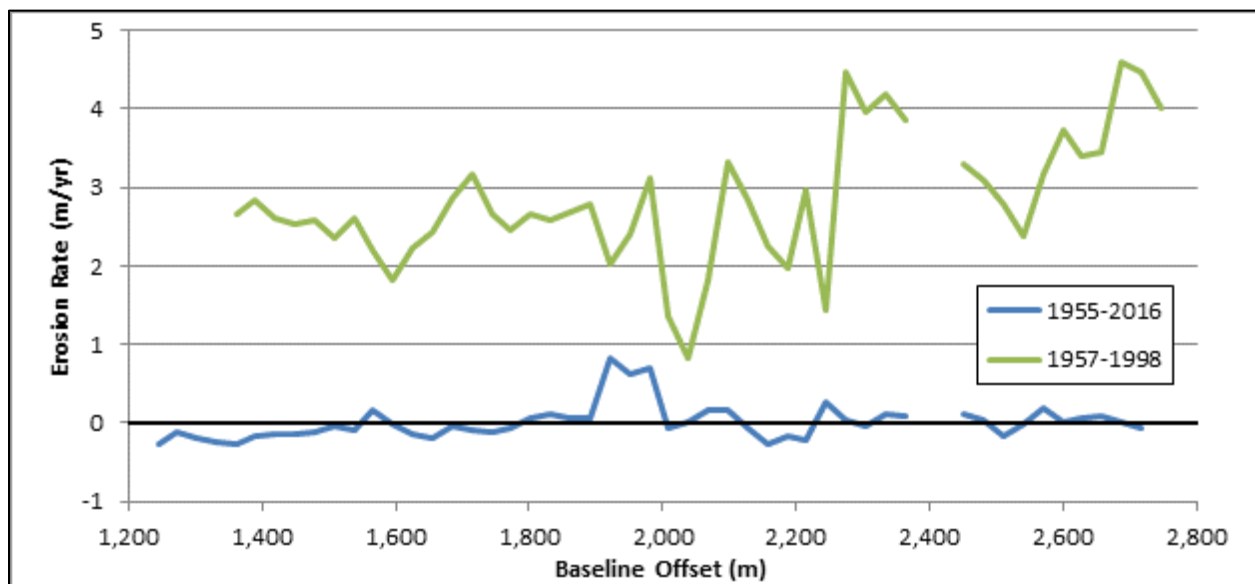
Figure 5.5 Erosion Rates - Baseline Segments 3, 4 and 5

Figure 5.5 and Figure 5.6 show a very high erosion rate across reaches 14 to 19 for one of the analysis intervals, and a mix of low erosion and accretion rates for the other interval. These reaches include both protected and unprotected shoreline. It is our expectation that the high erosion rates from the 1957-1998 analysis are the result of the erosion of fine nearshore sediments, a proportion of which was likely delta sediment deposits originating from the Chateauguay River. This idea is discussed in more detail in Section 5.5. Cobble-hardened sections of shore within Reach 19 showed no signs of either recent or past erosion that would be consistent with the high rates shown in Figure 5.6.

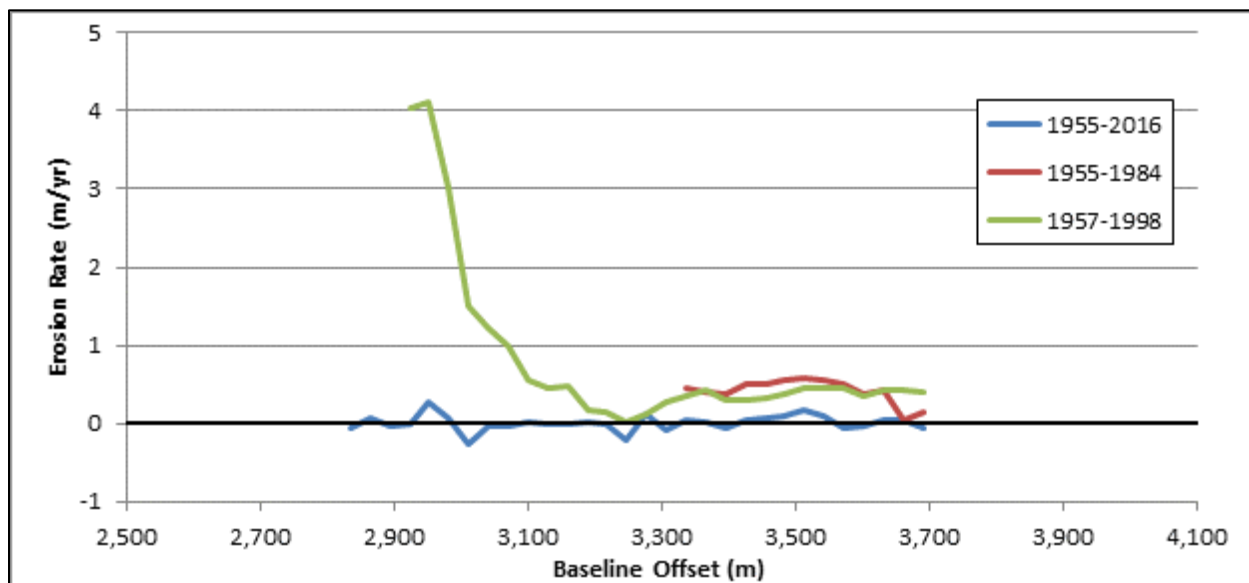
Figure 5.6 Erosion Rates - Baseline Segment 6

Figure 5.6 also shows somewhat conflicting results between 3,300m and 3,700m on the baseline, which extends from Reach 22 to about the mid-point of Reach 31. The April 1955 to 2016 analysis shows relative stability of the shore, but the June 1955 to 1984 and the 1957 to 1998 analyses show relatively high erosion rates in the order of 0.5m per year. This might be attributable to the effects of water levels with low erosion on the upper portion of the bank but more erosion on the lower portions of the profile. While that is a speculative assessment, it seems reasonable to treat Reaches 22 to 31 as being erosion prone. This coincides with the area having the highest wave exposure within the study limits.

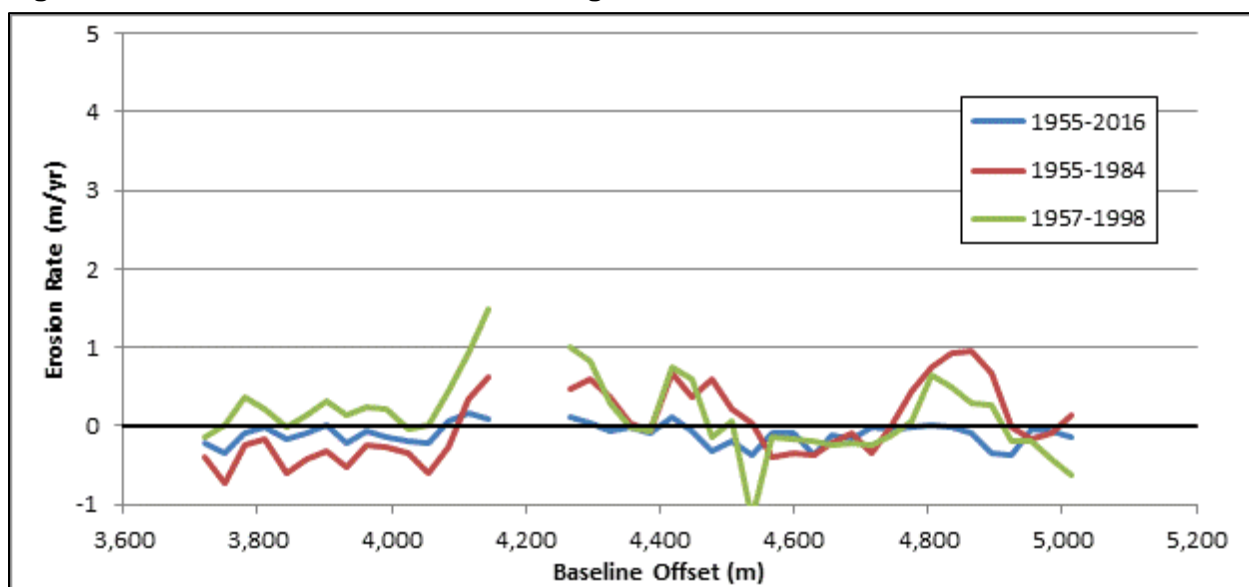
Figure 5.7 Erosion Rates - Baseline Segments 7 and 8

Figure 5.7 is difficult to interpret and may reflect shoreline filling as well the construction of different protection structures. It also likely demonstrates the uncertainty of the analysis results due to the factors described above. It appears as if the shoreline from approximately 4,400m to 4,550m (part of Reach 42) and from approximately 4,750m to 4,950m (Reach 43) are erosion prone but the data is not consistent enough to rely on a specific erosion rate.

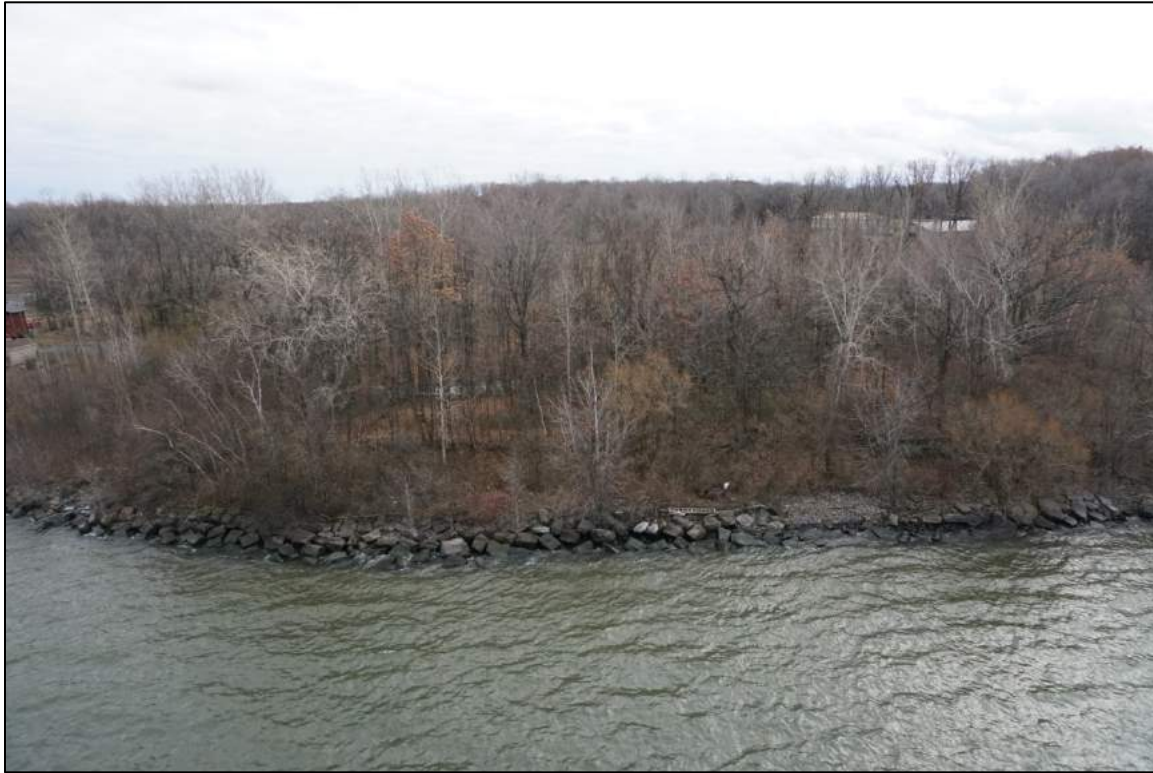
Reach 5 (Lots 2, 3, 4, 5, 6 and 7-1) has an approximately 125m long armour stone revetment. It consists of a single layer of randomly placed 1 to 2 tonne armour stones with a crest elevation in the order of 22.5m. That gives a high water level freeboard of about 0.6m and a negative freeboard under design conditions. Overtopping at high to design water levels will range from moderate to severe. There is no splash pad to protect against overtopping water so damage to the backshore can be expected under those conditions, although none was observed during our review.

No toe embedment or flank protection was noted, but no flank erosion or toe settlement problems were noted either. Rip rap under the armour provided an adequate filter layer, but settlement in some areas indicated a loss of fines from the bank. Overall the revetment appears to be functioning adequately and can be expected to continue to function as it has for some time, unless it is damaged by a significant storm event at high to extreme water levels. No specific repair or maintenance requirements were noted at this time

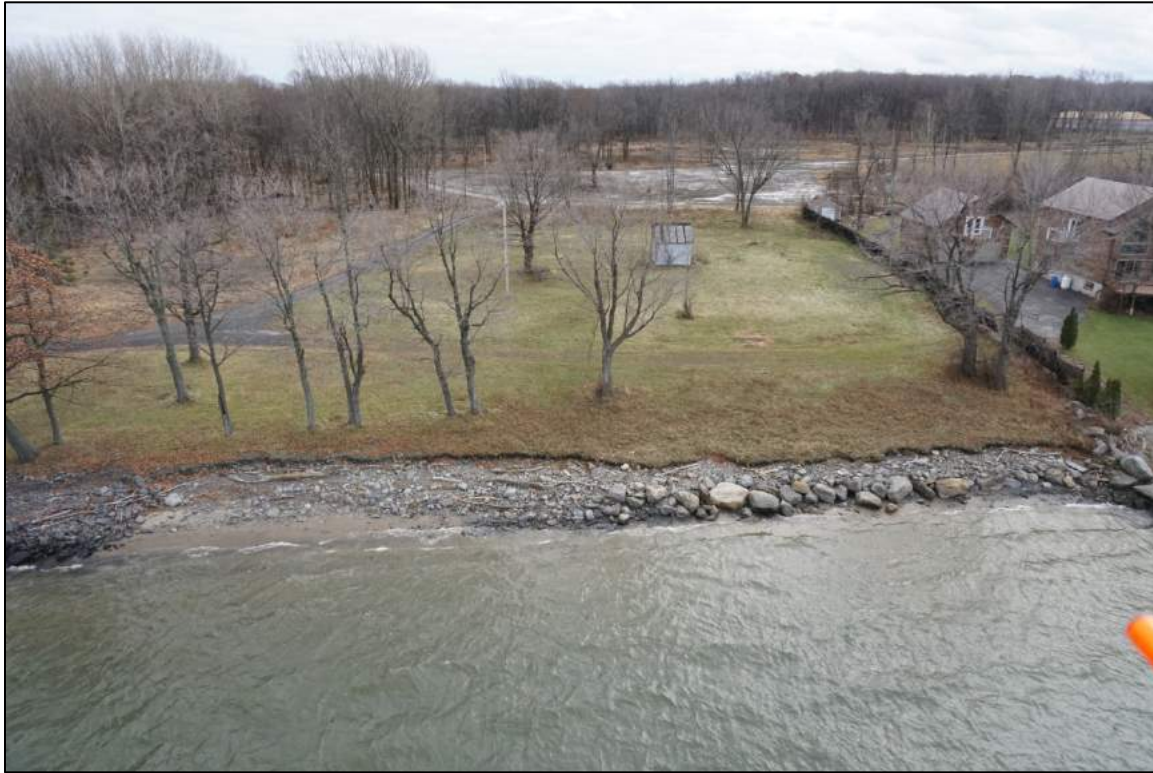
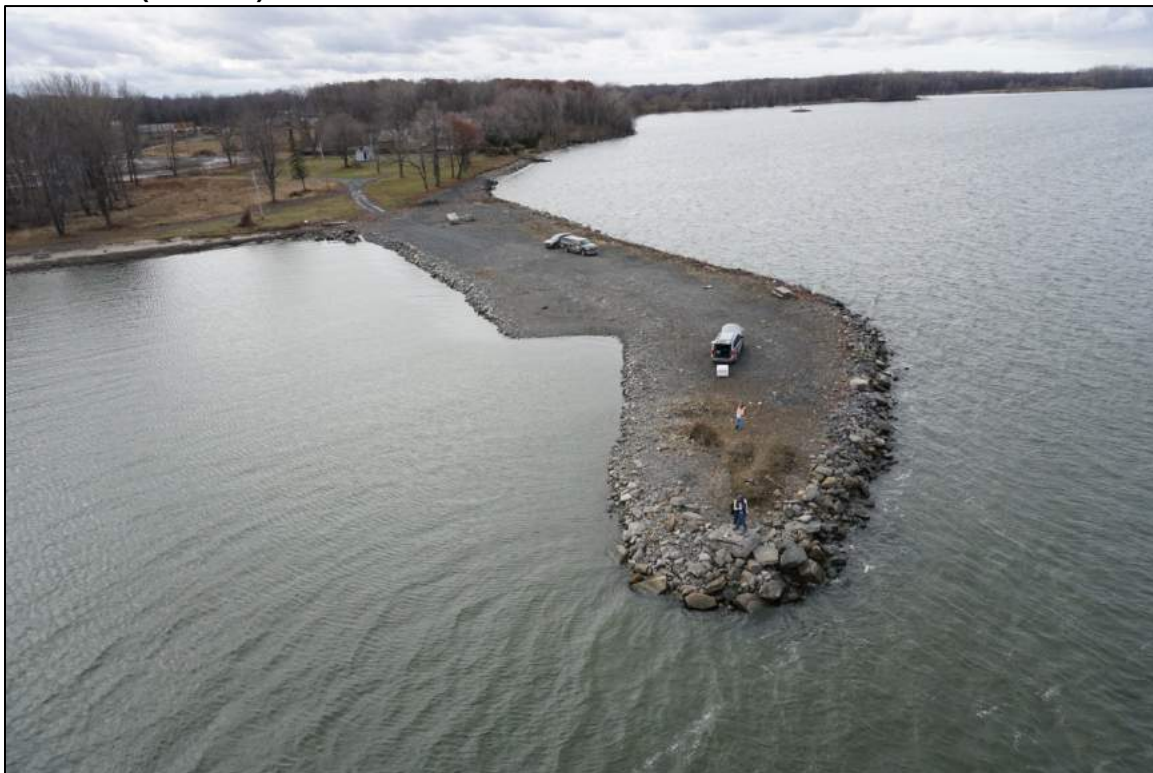
Reach 11 (Lot 7-3) contains a recently constructed blast-rock rip rap jetty with larger boulders armouring the exposed westerly side and tip of the jetty. A wide section of rip rap extends a short portion along the shore to the west where it protects an eroding low bank. The jetty has a crest elevation in the order of 22.5m so it will have overtopping characteristics similar to that described for the revetment in Reach 5. Some damage to the jetty surface would occur due to overtopping under severe conditions, but it would be relatively simple to repair by re-grading the stone material.

There is no need for repair or maintenance to the jetty itself at this time, but the shoreline to the west of the 8m wide rip rap is lacking in stone and there is minor bank erosion.

The boulders and rip rap along the shoreline would be expected to provide some structural habitat (niche spaces, edge, cover, etc.) for a range of fish and would provide surfaces for invertebrate and other fish-food items to colonize. However, it must also be noted that this structure has covered a significant amount of river bed fish habitat, which is a notable detriment. If proper sedimentation controls were not employed during construction it is expected that a significant amount of fines would have been introduced to the river due to the nature of the rock material used. That is also detrimental to fish habitat.

It is our understanding that the jetty was constructed without any permits. In some jurisdictions the landowner would be required to remove the structure due to the environmental impacts it had and because it was constructed without permits. It is our opinion that the environmental impacts caused by the jetty would have been mostly due to its construction method, and those impacts have already occurred. Removing the structure now would repeat those impacts rather than mitigate them, so we do not see a significant physical benefit to removing it. Whether or not it should be removed because of permitting issues is beyond our scope for comment. However, we discourage the construction of any other similar large structures without following both environmental and regulatory/administrative practices, such as those discussed in Section 8.5.7.

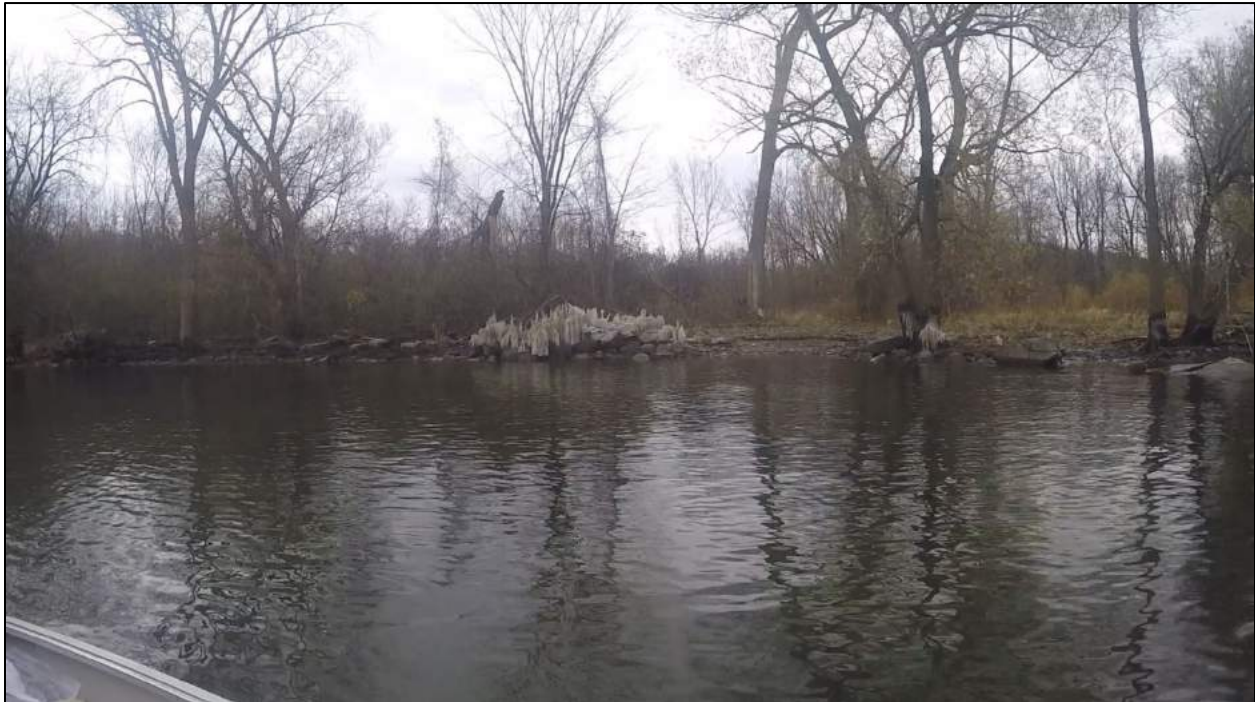
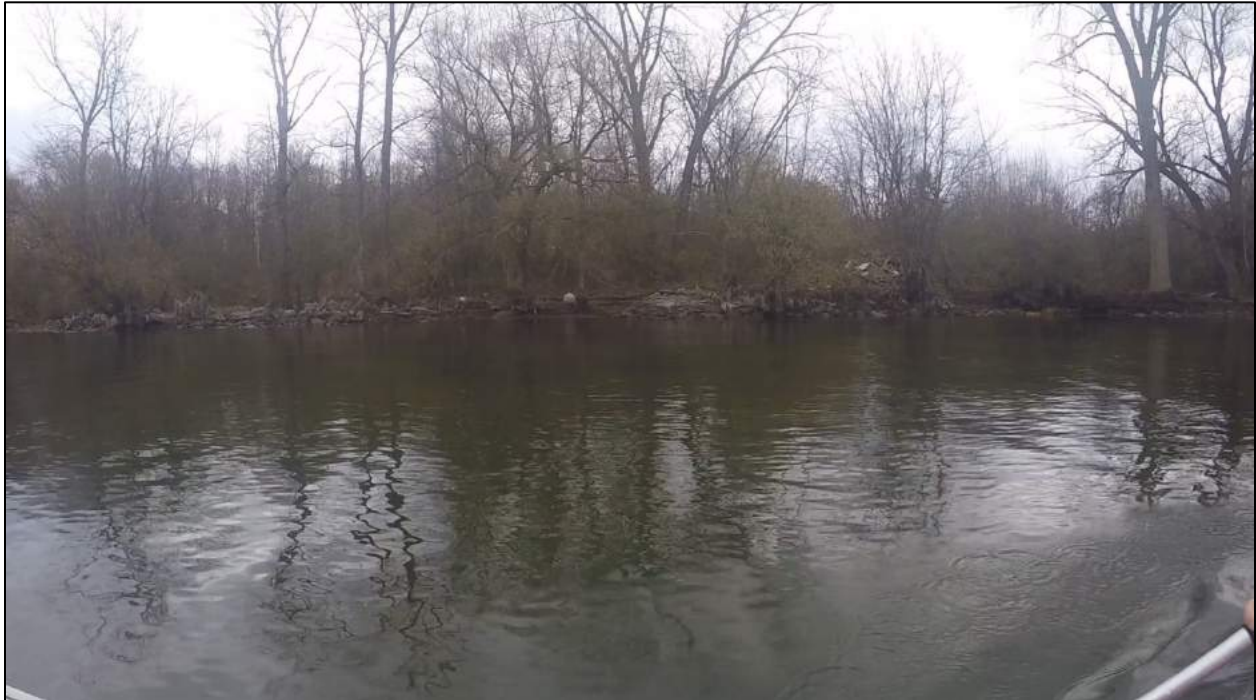
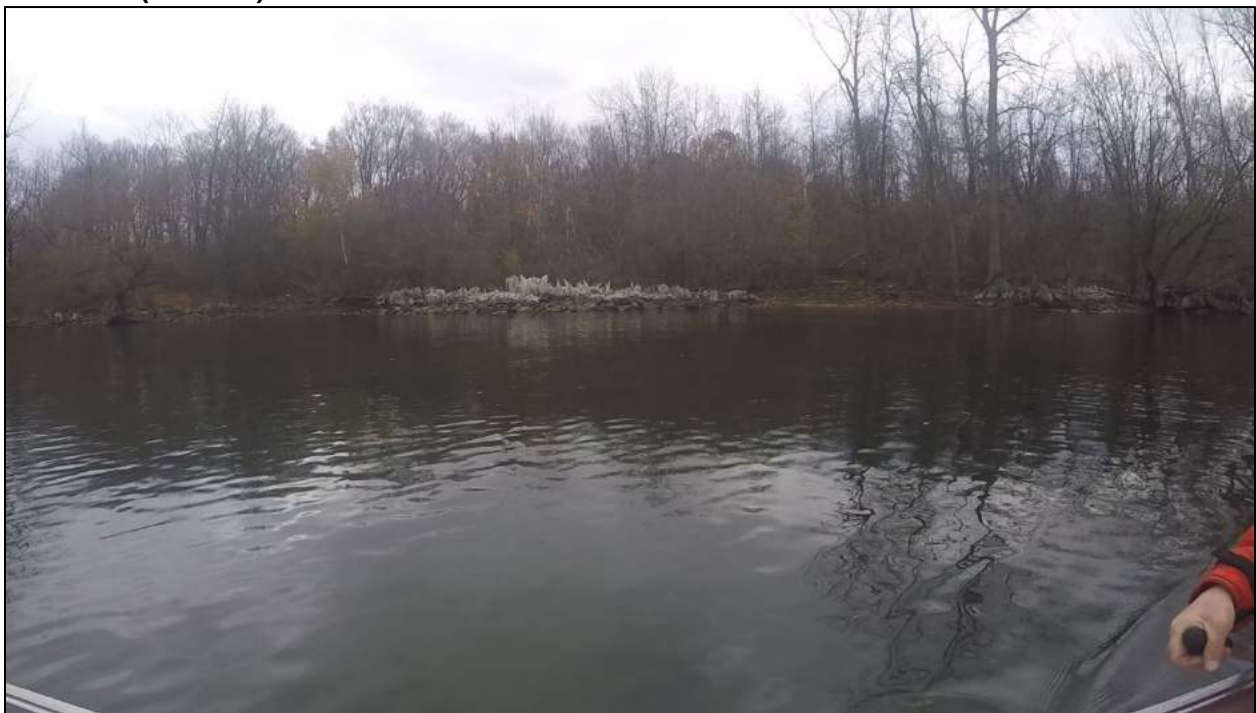
Reach 19 (Lot 18-1) is a 284m long section of shoreline with varying lengths of unprotected shore, small boulder and rip rap cover on the shore, and narrow boulder piles. This reach was not inspected closely due to access issues but a review of video taken during the boat review showed that one boulder pile located near the centre of the reach was perhaps long enough to be viewed as a small boulder revetment. That revetment is shown in the Reach 19 (photo 3) photograph in Appendix A. It covers only a small fraction of the shore in this reach; what is being protected was not apparent from the boat review.

The boulders are large enough to be stable during design conditions. The crest elevation is in the order of 22.5m so it will only be overtopped during high to extreme water levels. Based on the other structures along the shore, it is unlikely that there is a filter layer, toe protection, or flank protection. This revetment is likely to be providing adequate protection at normal water levels and can be expected to continue to do so for some time, unless damaged by a severe storm at high water levels. There is no readily apparent need for either repair or maintenance at this time.
